Re: Jacob Hands – Las Cruces Wastewater Treatment Plant; Major; Individual Permit; SIC 4952; Compliance Evaluation Inspection; NPDES Permit NM0023311; March 21, 2017

NPDES Compliance Inspection Report

City of Las Cruces – Jacob Hands Wastewater Treatment Plant
Compliance Evaluation Inspection
NPDES Permit No. NM0023311
March 21, 2017
Further Explanations

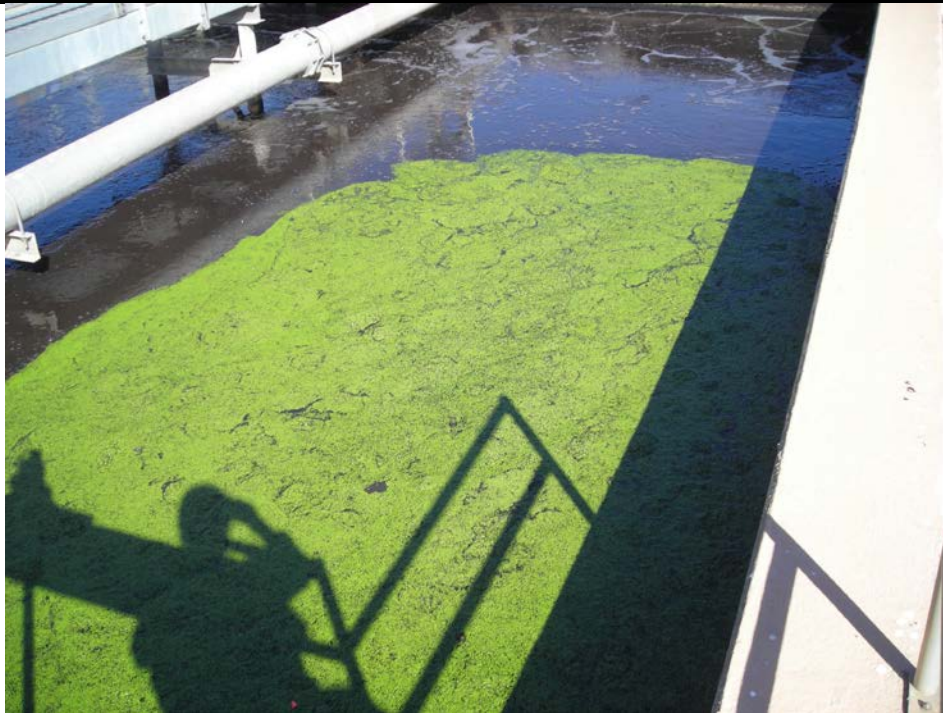
**NMED/SWQB
Official Photograph Log
Photo # 1**

- Algae was growing in the aeration basin (photo 1).
- An improvement noted since the last inspection is that a new system was installed for brushes to continuously clean algae at the clarifier (photo 2).
- During this inspection, the secondary clarifier had uneven flow over the weirs. Wastewater should be evenly dispersed across the entire cross section of the tank (photo 3).
- The visual gage on the parshall flume is damaged and unreadable, the flowmeter is calibrated monthly by facility personnel measuring flow with a ruler (photo 4).

Subject: algae growing on aeration basins

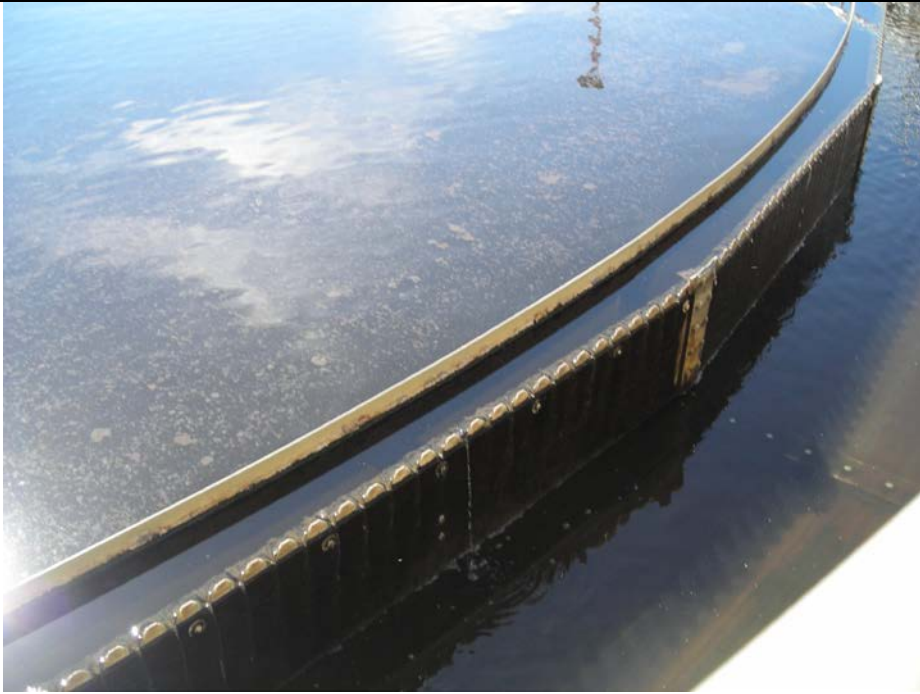
NMED/SWQB Official Photograph Log Photo # 3		
Photographer: J. Foote	Date: 3/21/17	Time: abt 10 am
City/County: Las Cruces/Dona Ana County		State: New Mexico
Location: Jacob Hands WWTP		
Subject: uneven flow from clarifier

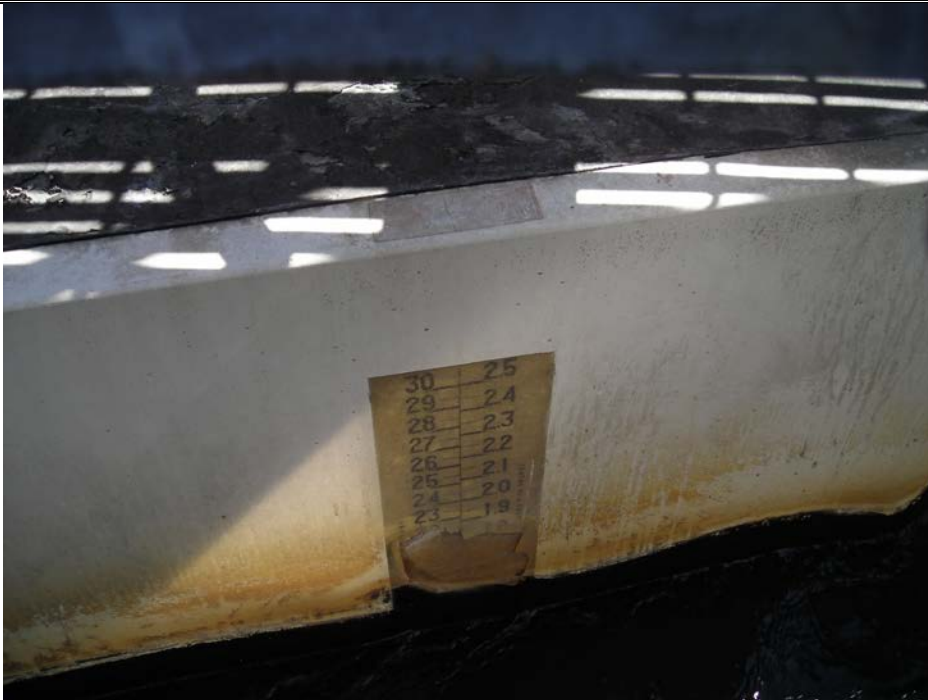
NMED/SWQB Official Photograph Log Photo # 4		
Photographer: J. Foote	Date: 3/21/17	Time: abt 10 am
City/County: Las Cruces/Dona Ana County		State: New Mexico
Location: Jacob Hands WWTP		
Subject: parshall flume

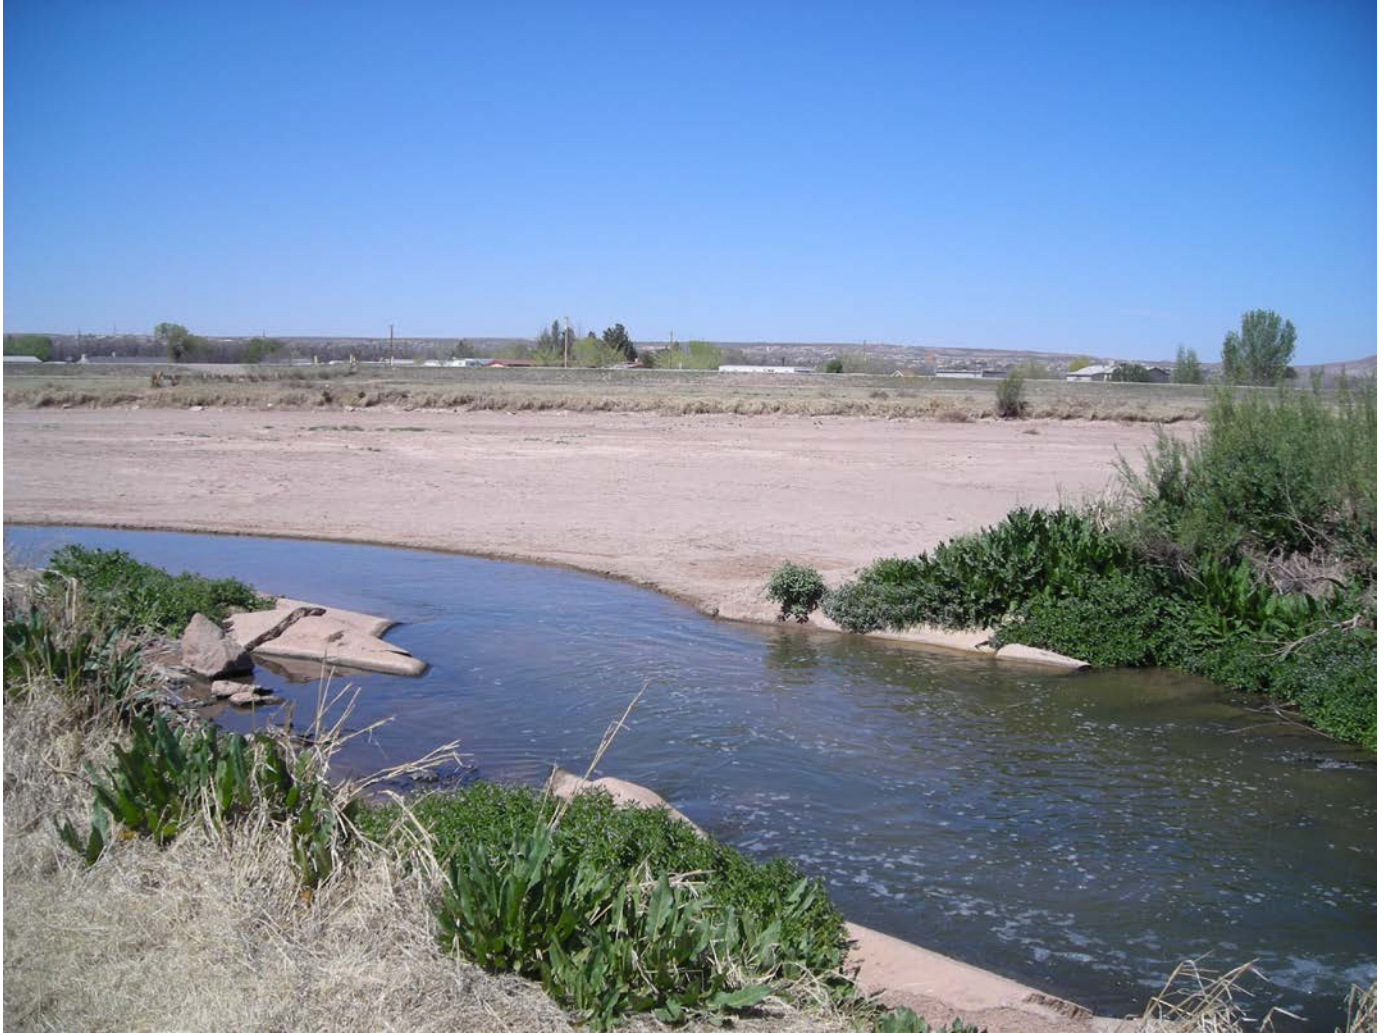
**NMED/SWQB
Official Photograph Log
Photo # 5**

Subject: discharge at Rio Grande
